# Manhole Inspection Summary

Manhole # S23C1\_011MH

Insp Date: **7/8/08 1:40 PM**

**Location** Address: **2400 Wilgrey Ct.**

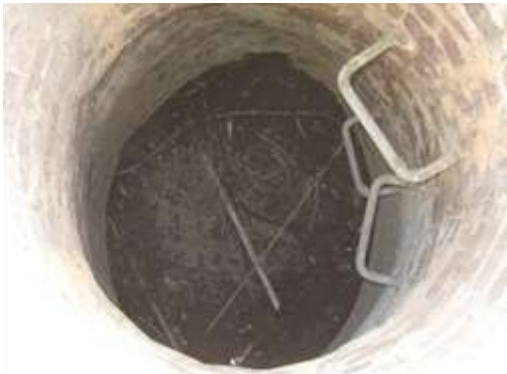
Defect 2

Infiltration: ☐ None ☐ Joint ☐ Cracks ☒ Mortar ☐ Roots ☒ Wall

infiltration at corbel mortar & wall

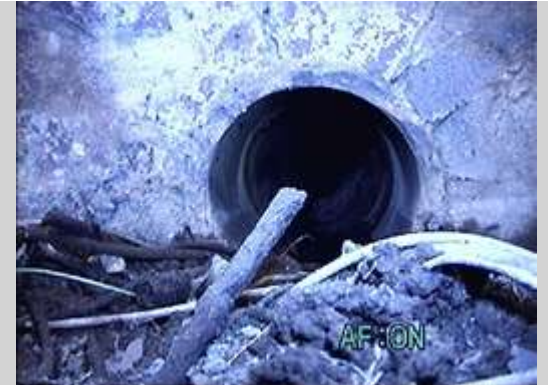
12 O'Clock Outflow

8 in. Circular Gravity Sewer  
Pipe Out @ 12 O'Clock
